MISCELLANEOUS PAPER GL-90-7

# CONDITION SURVEY AND PAVER IMPLEMENTATION, EDWARDS AIR FORCE BASE (NORTH BASE), CALIFORNIA

Ross A. Bentsen

Geotechnical Laboratory

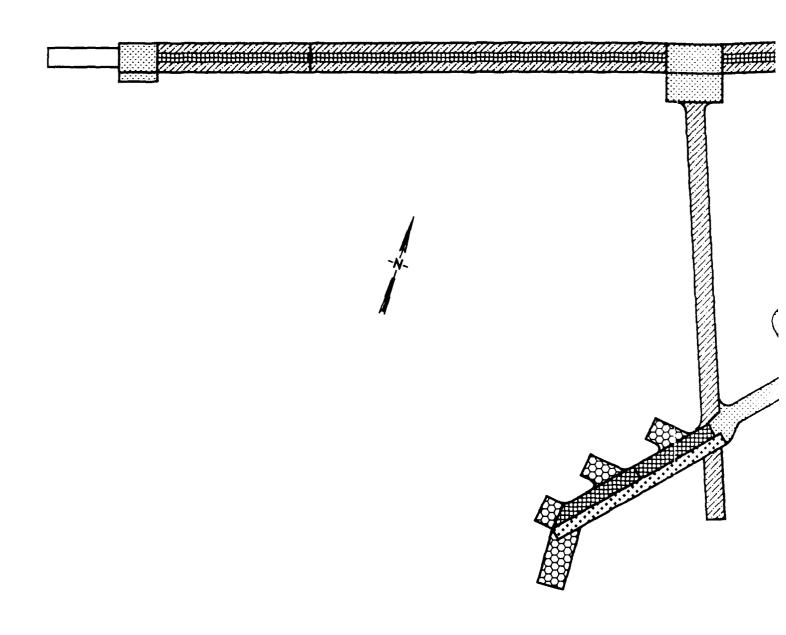
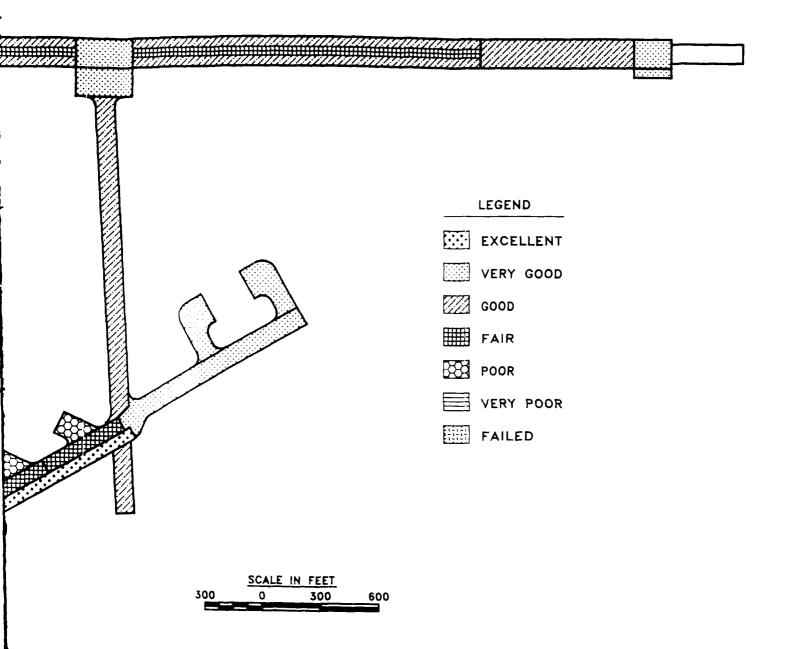
Figure 7. Pavement condition ratio

- 12. The majority of the pavement features at North Base are rated from fair to very good conditions with some features rated poor and excellent. Figure 7 illustrates the condition ratings of the features at North Base. Photos 1 through 6 show various distresses that were observed on the airfield pavements.
